Comprehensive Building Conditions Assessment Report

EFI File No.: 014.04649
December 4, 2022

Westborough Country Club
121 Main Street
Westborough, Massachusetts

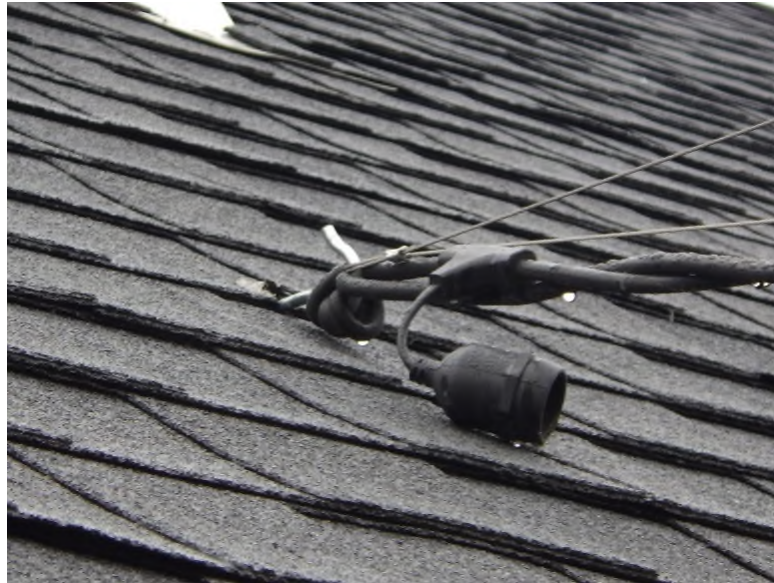
Photograph 2: Screw Eye Hook for Exterior String Lighting Screwed Through Roof (one of several)

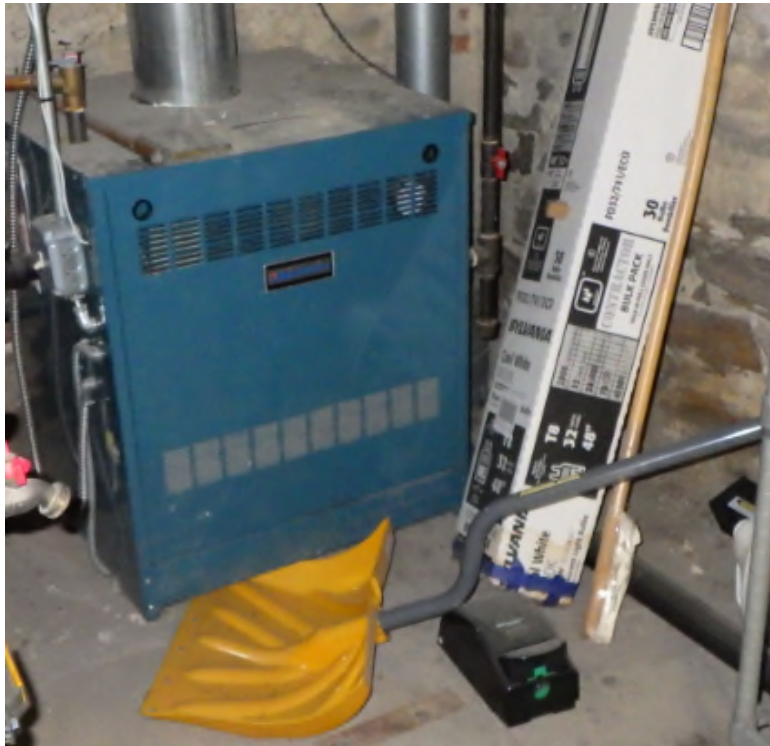
for combustion air and the code requires that combustion air for an unsealed combustion device is provided by either a fan or air intakes through an outside wall. EFI recommends that the controls for the fan are revised so it operates when the boiler operates. EFI noted that combustible material was stored near the boiler. All such material should be stored at least three feet from the boiler.

Figure 2: Combustible material should be stored further away from the boiler.

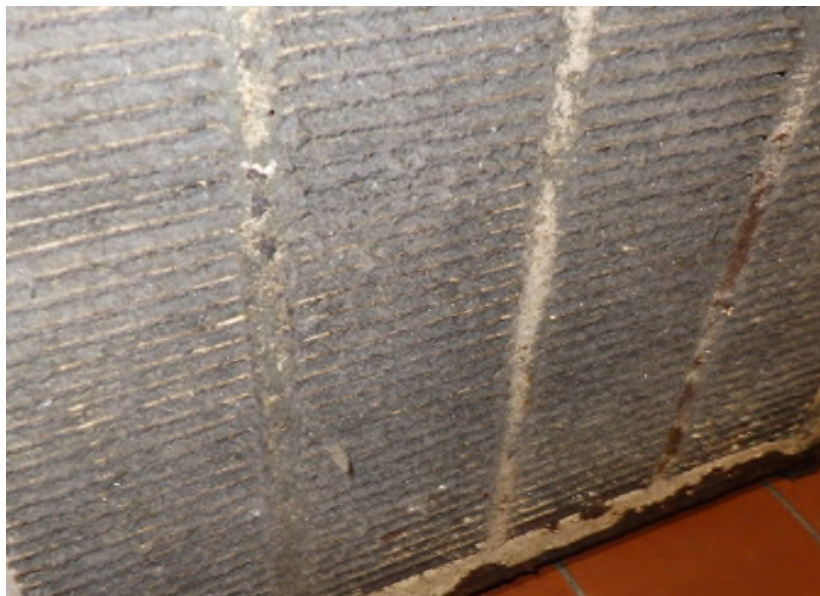
Figure 4: Intake for kitchen area AC unit needs to be cleaned.

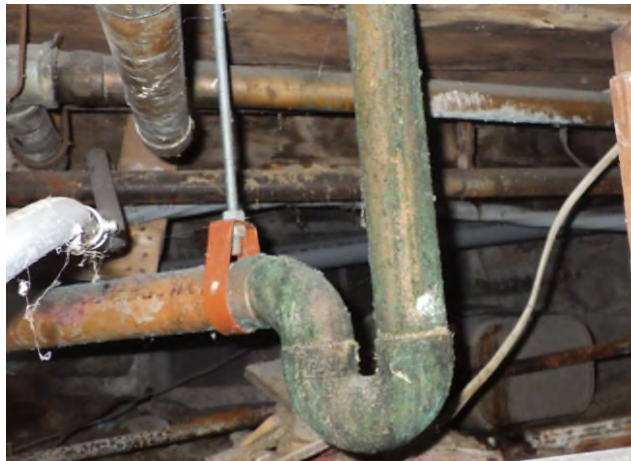
The wastewater leaves the building in the basement under the kitchen area. There is a crawlspace in this area with a lot of piping in it. Some piping shows heavy corrosion and access to this space is impossible without removing the outside wall siding or the floor in the area above. Access to this area should be increased soon as there is an impending hazard in this area of leaks/failures and there will be an upcoming necessity to make substantial repairs/modifications to the plumbing in this area.

Figure 5: Inaccessible crawl space. Several pipes show significant corrosion.

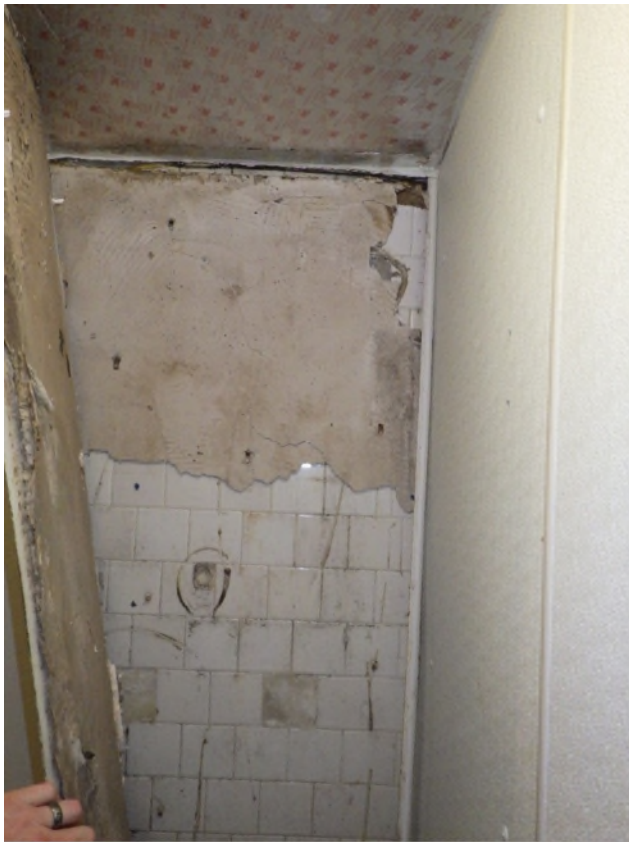
One of the basement coolers included a wipe-clean surface that appeared to be installed over drywall/plaster, which was installed over a tile surface. The tile surface may have previously been a shower, although the wall/cooler was not largely disassembled to investigate the origin. The plaster-like material that was sandwiched between the tile and interior wall covering was crumbling/failing causing the wall to bulge inward and delaminate internally. It is likely that the plaster was not properly sealed from the moisture of the cooler and failed as a result of the way in which the cooler was constructed. Assuming that similar, improper construction of the cooler is present throughout, the entire cooler should be reconfigured.

Photograph 4: Cooler Wall Failing

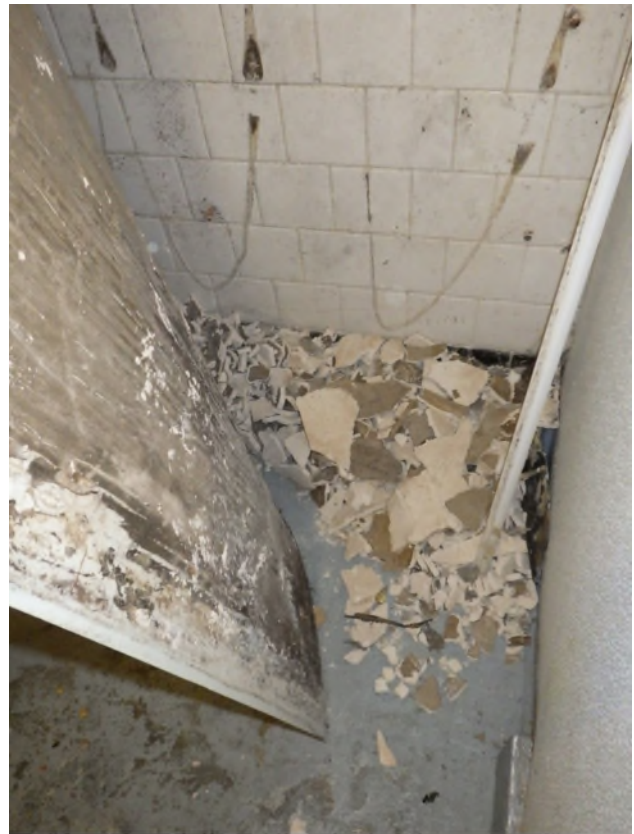
Photograph 5: Crumbling Wall Material, Basement Walk-in Cooler

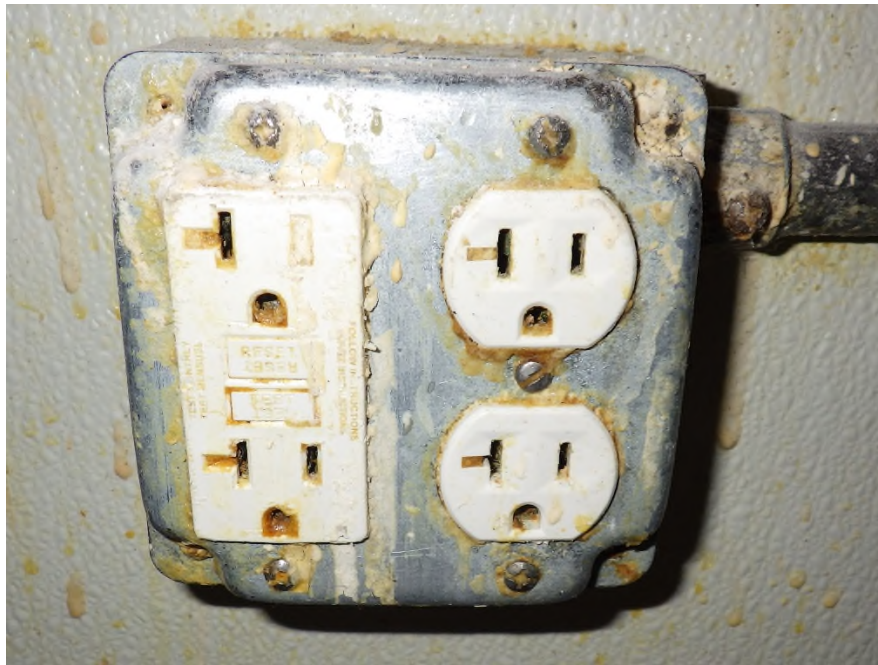
Photograph 6: Grease/Food Contaminated Electrical Distribution Components

- EFI recommends that the kitchen electrical components be replaced within waterproof systems, and all surfaces be professionally sanitized.

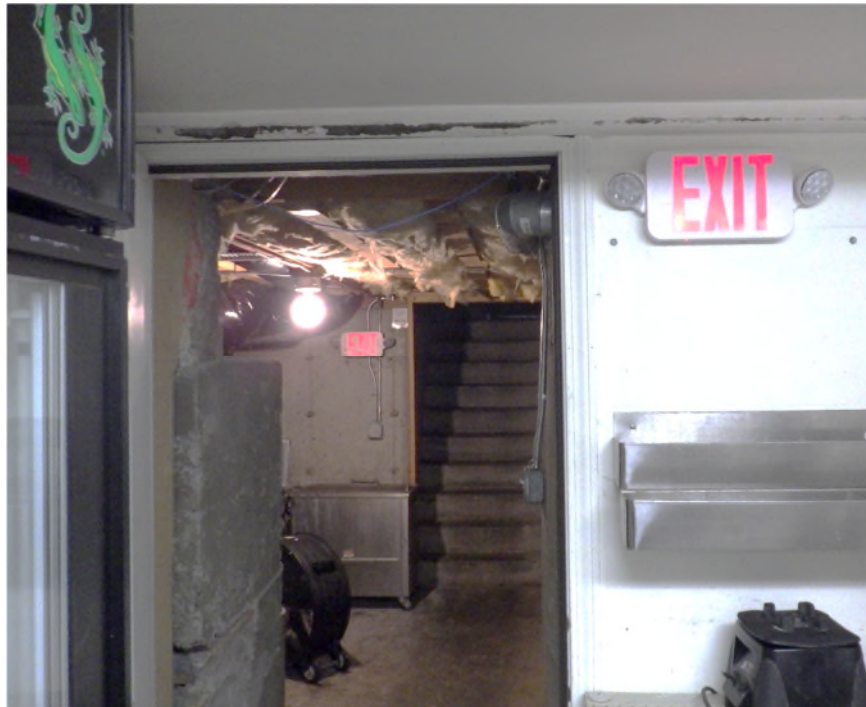
The bulkhead is marked on the interior with illuminated EXIT signage, which is improper. The bulkhead doors, latches, stairs, exterior discharge, and lack-of railings or top-landing are all improper for an egress path. For this to be considered an egress path, the entire egress system would require reconfiguration which would likely snowball into structural matters as it would involve the foundation as well as issues with the exterior parking lot.

Photograph 7: EXIT Signage Directing Occupants to the Bulkhead

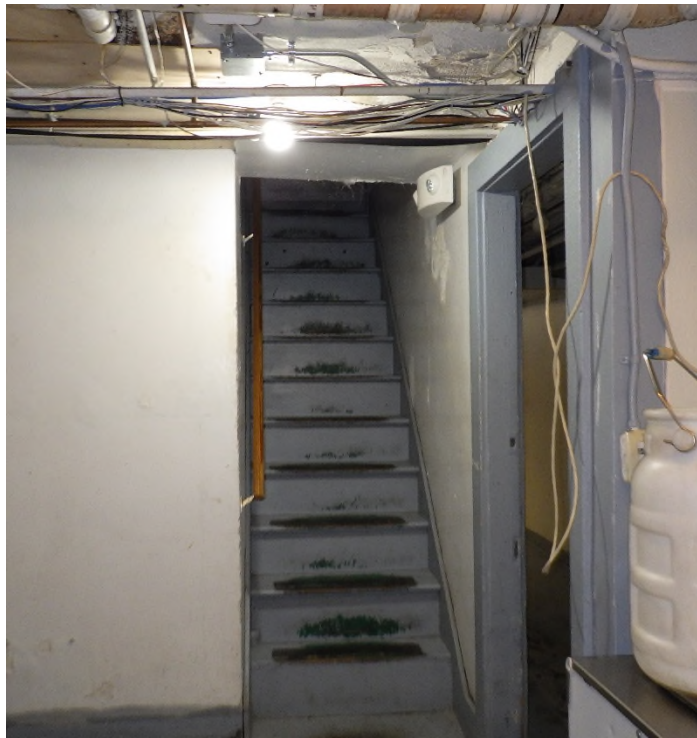
- The threshold at the top of the stairs was a trip hazard.
- There was insufficient headroom clearance at the top and bottom.
- The risers were 9" high.
- There was no room at either the top or bottom to permit modifications to the stairs necessary to comply with current code requirements.
- The interior egress stairway is not enclosed.

Photograph 8: Interior Stairway to Bar

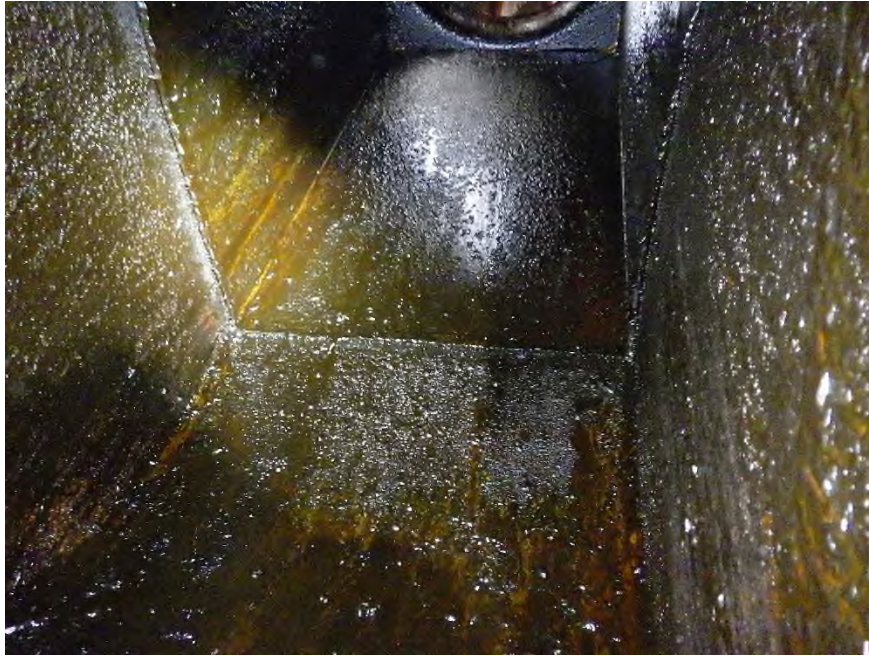
The commercial kitchen exhaust duct (“grease duct”) requires a cleaning, inspection, and maintenance. The exhaust system is contaminated with significant grease which has created a notable fire hazard and is due (or overdue) for an NFPA 96-compliant service. Consideration should be given to determine if the frequency and/or quality of ventilation system cleaning is adequate.

Photograph 10: Commercial Kitchen Exhaust Duct Grease Accumulation

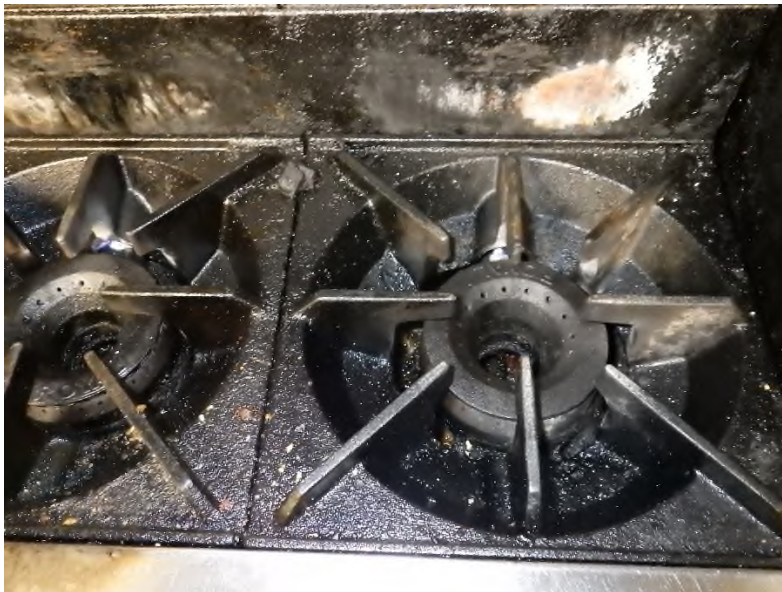
The cooking appliances in the commercial kitchen require a more robust/stringent cleaning/maintenance program than they are currently experiencing. The range, for example, was covered in grease-residue which creates a potential fire (and health) hazard.

Photograph 11: Commercial Kitchen Range

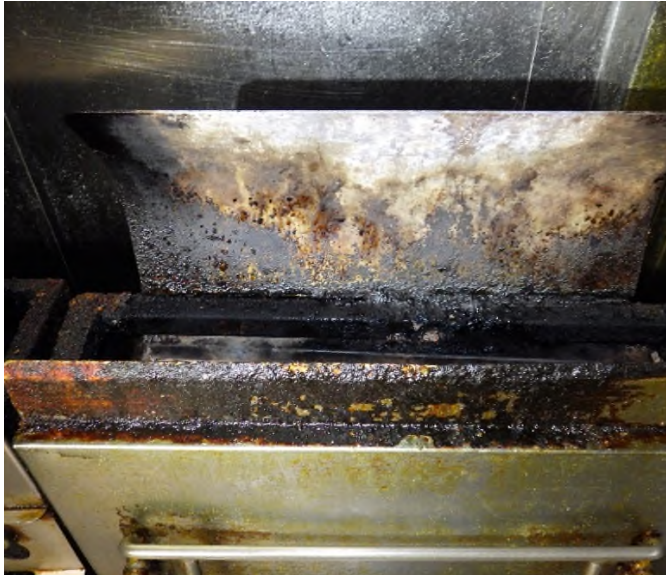
The fryers similarly require significant cleaning and in order to maintain a level of safety in the restaurant, should be cleaned and serviced regularly. The flues, sides, rear, and controls of the fryers were heavily contaminated with grease and cooking byproducts creating a significant hazard to the staff, occupants, and patrons of the restaurant and building as well as the Town of Westborough's building. As part of the controls, the fryer's pilot light, which has a standing flame, was surrounded by flammable grease accumulations.

Photograph 12: Contaminated/Soiled Fryer Flue

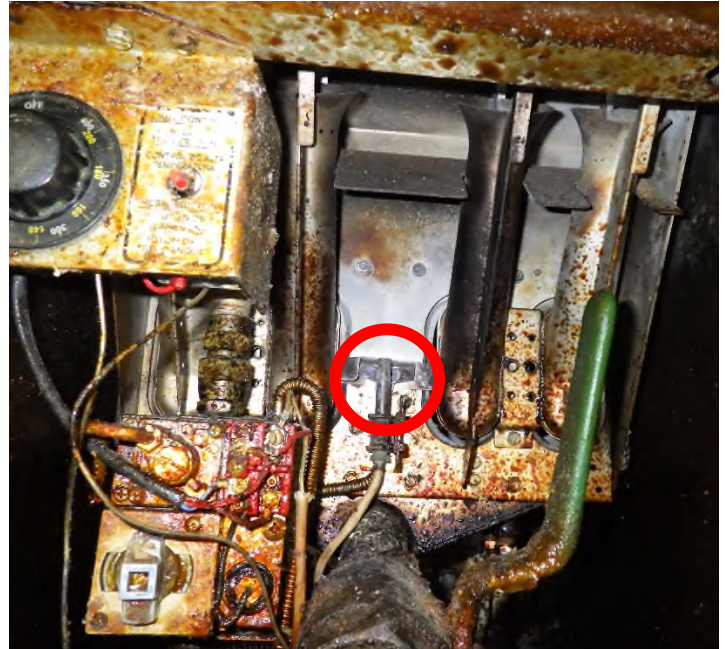
Photograph 13: Fryer Controls, Circuitry, Safety, and Burner Contamination with Grease (Pilot is Circled)

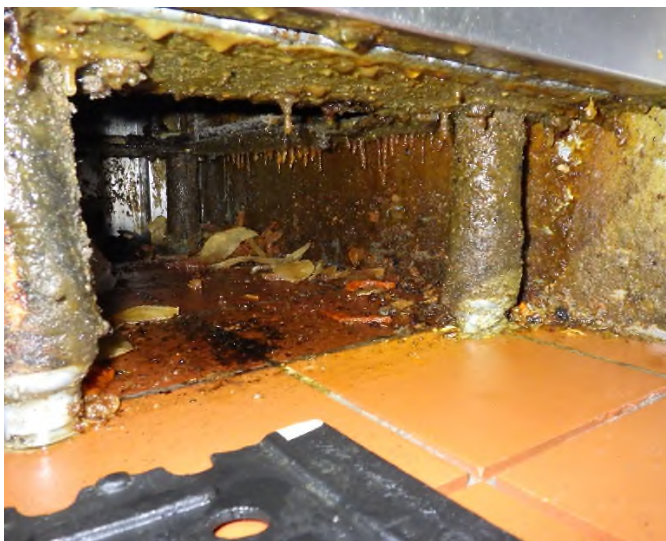
Photograph 14: Grease and Food Accumulations Beneath Fryer

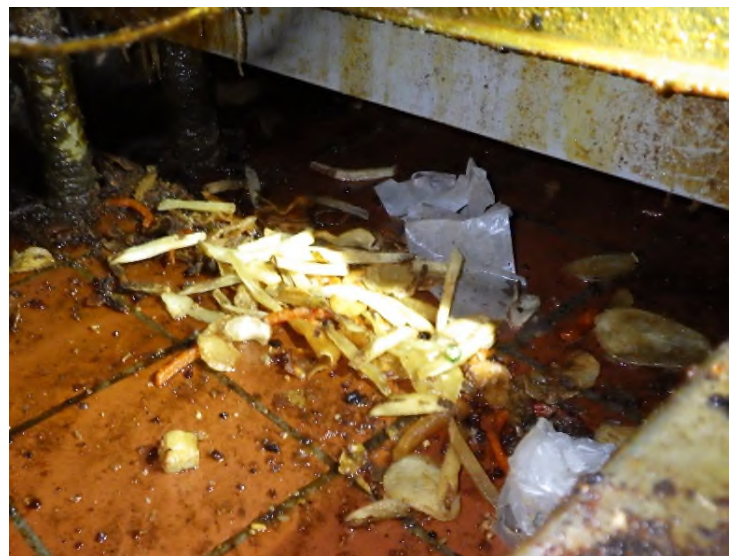
Photograph 15: Grease/Food Accumulations on Floor Significantly Overdue to Cleaning (Fire and Health Risk)

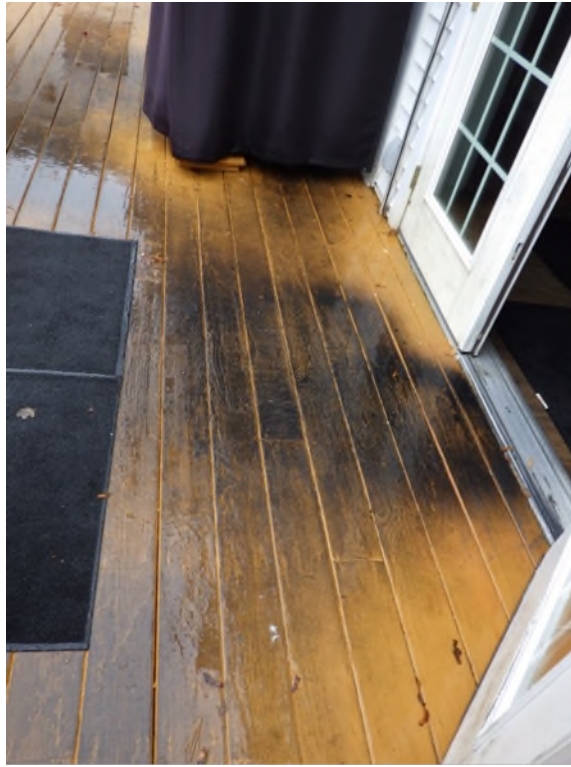
In the same way, the large rear deck was contaminated with grease residue on the walking surface adjacent to the French doors from the bar area that became notably slippery when wet.

Photograph 16: Slip Hazard on Large Rear Deck

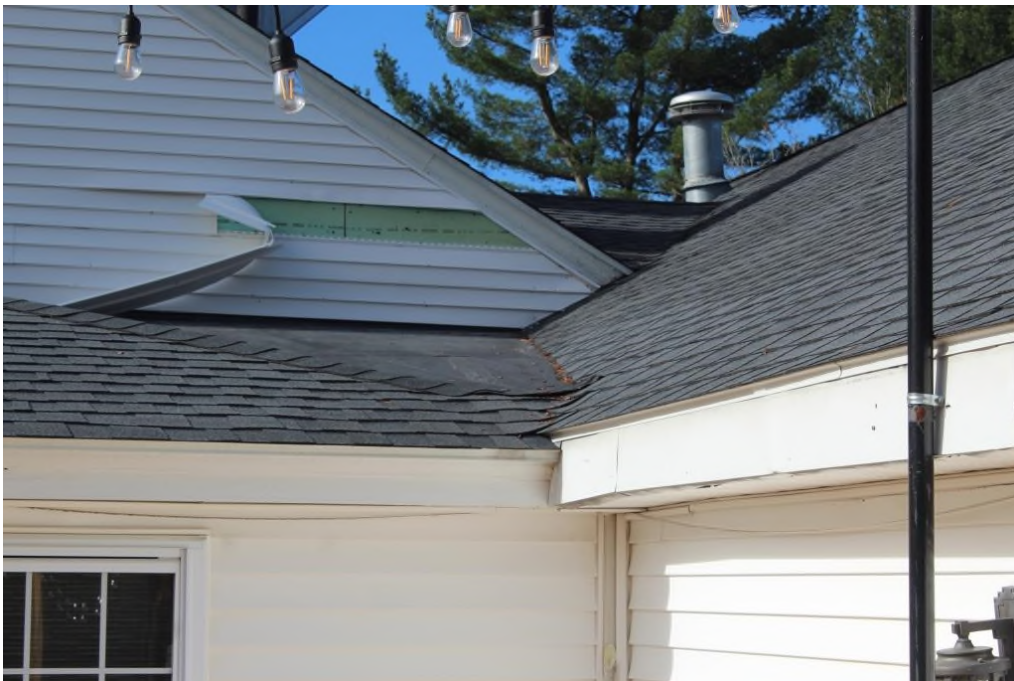
Throughout the building there were areas where the exterior siding was visually failing despite having been repaired a number of times. The siding itself was visibly wavy and inconsistent, which indicates likely breaches in the protection it provides and there were a number of areas where the siding was tacked/nailed back onto the building. A portion of the vinyl siding above the EPDM roof was pulled free from the building and requires repair. See Picture #10.

Photo No. 10: Location of EPDM roof membrane and damaged siding, above east portion of bar at intersection to Pro Shop.

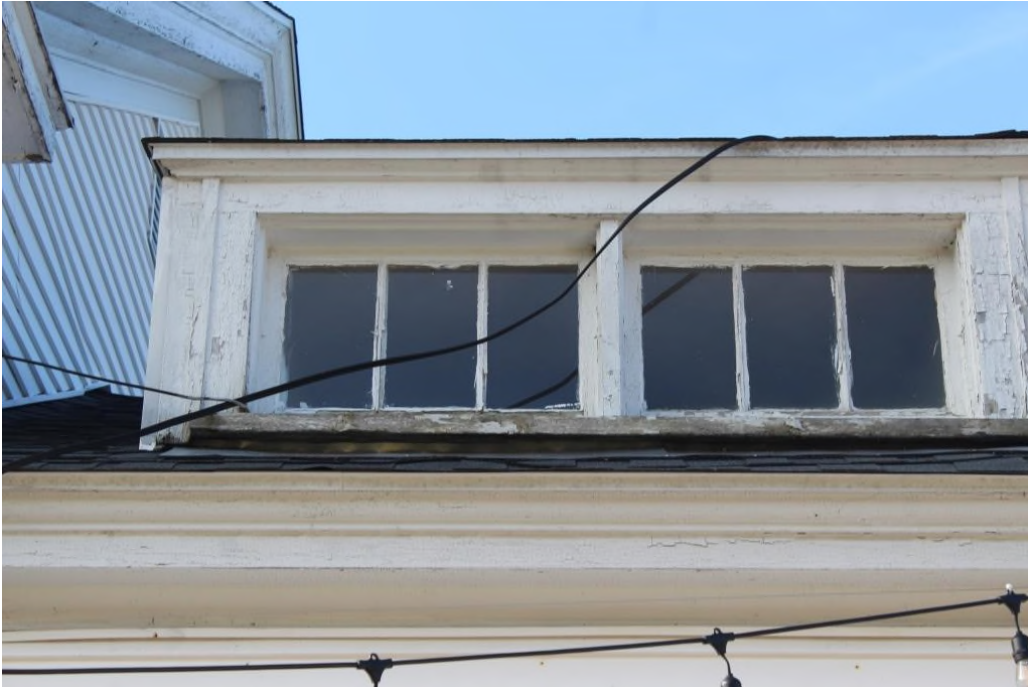
Photo No. 11: Peeling paint and water damage top second floor window.

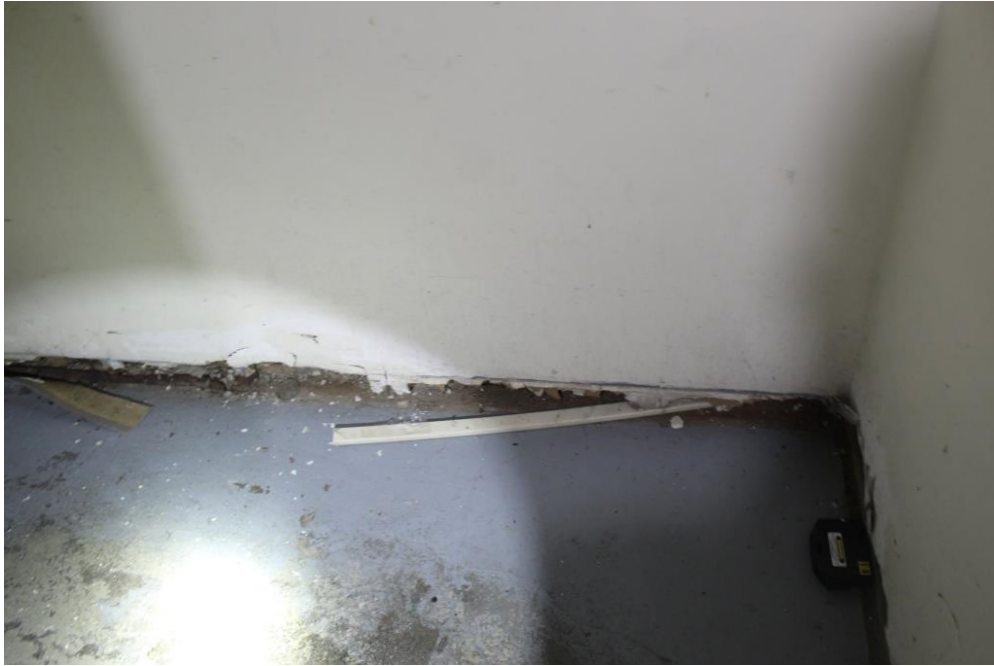
Photo No. 13: Water damage to baseboards in basement.

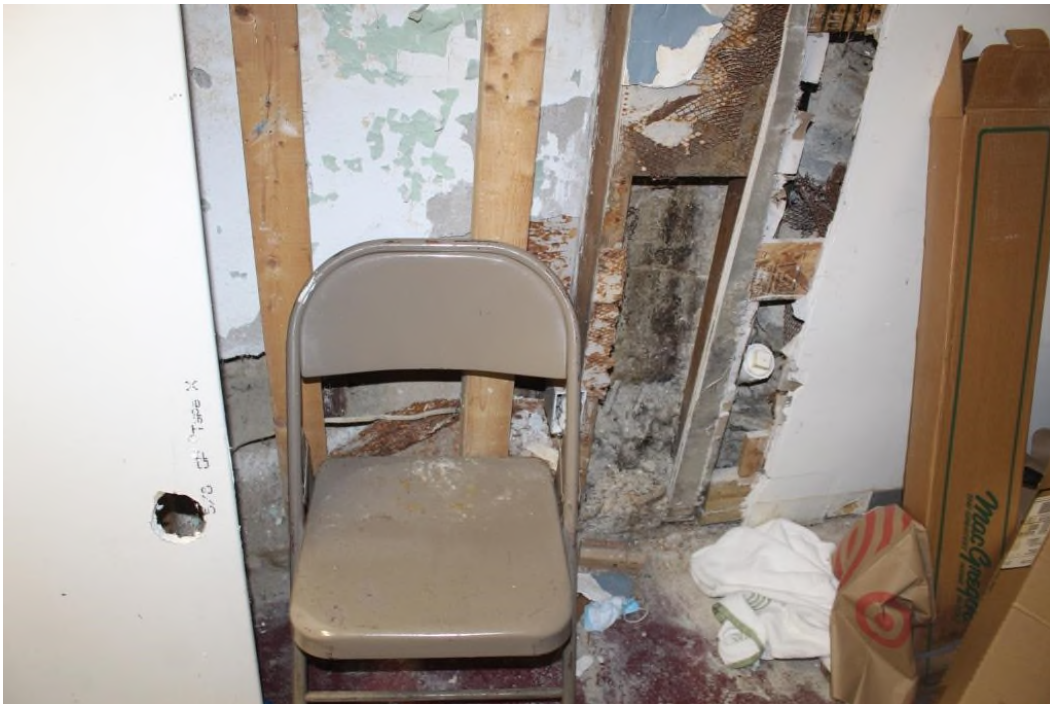
Photo No. 14: Partially removed wall in basement due to reported flooding loss.

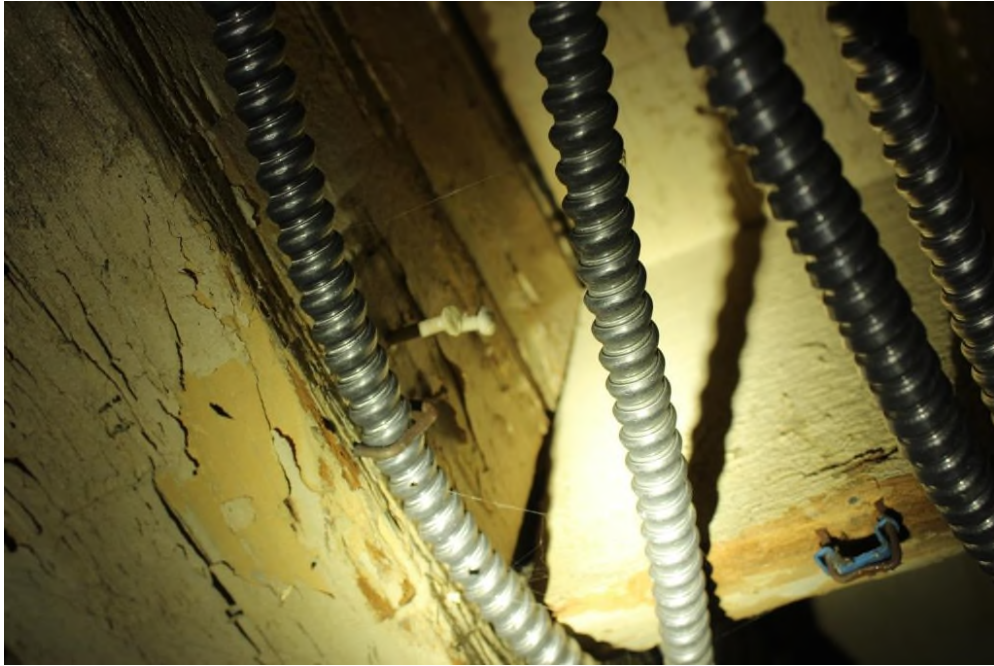
- Water damage and minor rot was observed to some first-floor framing in some areas of the crawl spaces.
- There were numerous interior brick bearing walls, all of which require repointing.

Photo No. 21: Typical mortise and tenon framing condition. Minor rot observed.

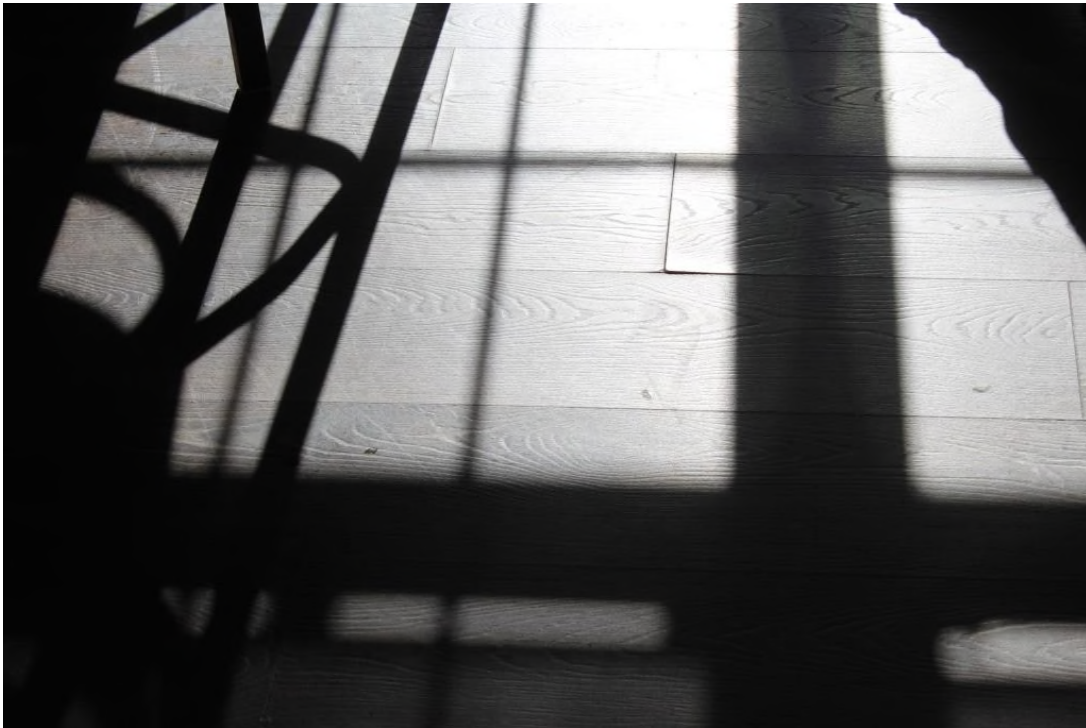
- The floor was covered with what appeared to be a glued laminate vinyl flooring. The flooring was peeling up at the butt ends. See attached photographs.
- There was no evidence of water stains or damage to first floor or the first-floor ceiling.
- No structural framing of the second floor or ceiling framing was visible from the first floor.
- See Pictures #22 through 27.

Photo No. 24: Vinyl flooring peeling up. Typical throughout.

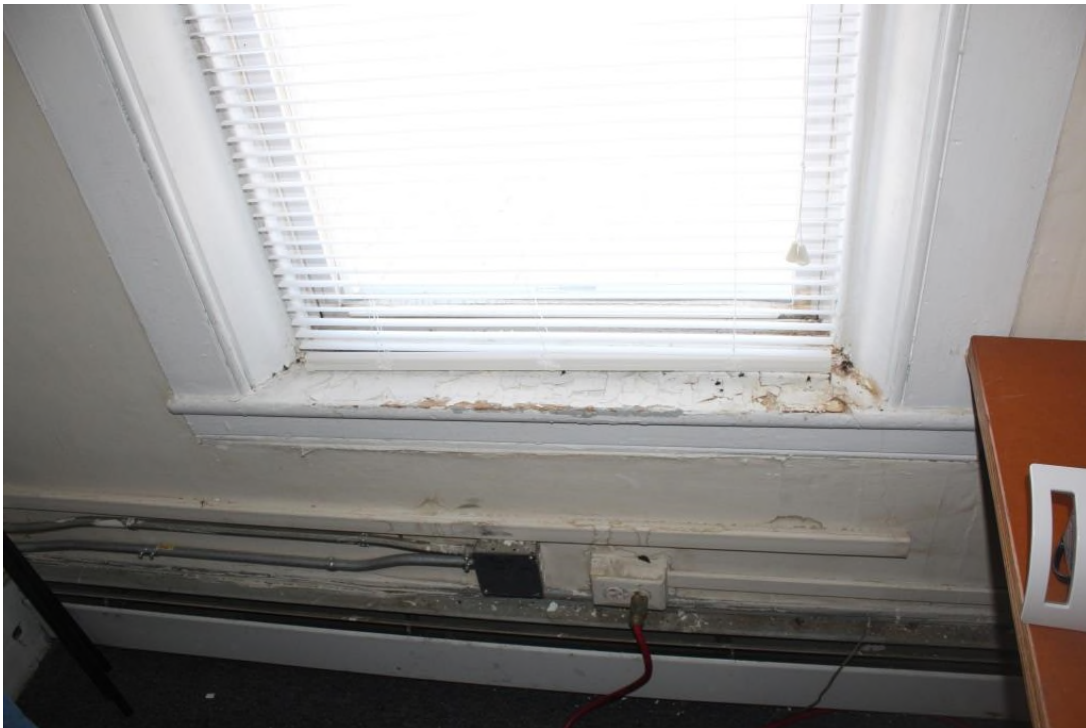
- No water stains were noted on the floor.
- Water stains were noted around and below some of the windows.
- Water stains were noted on a drop ceiling panel.
- In the second-floor mechanical closet adjacent to the north wall, the roof framing consisted of a variety of members which were not properly supported or connected. Some of the framing was cut and notched to fit around ducts and pipes. Evidence of water stains was present throughout the closet.
- See Pictures #28 through 33.

Photo No. 28: Typical second floor window. Note water stains on sill.

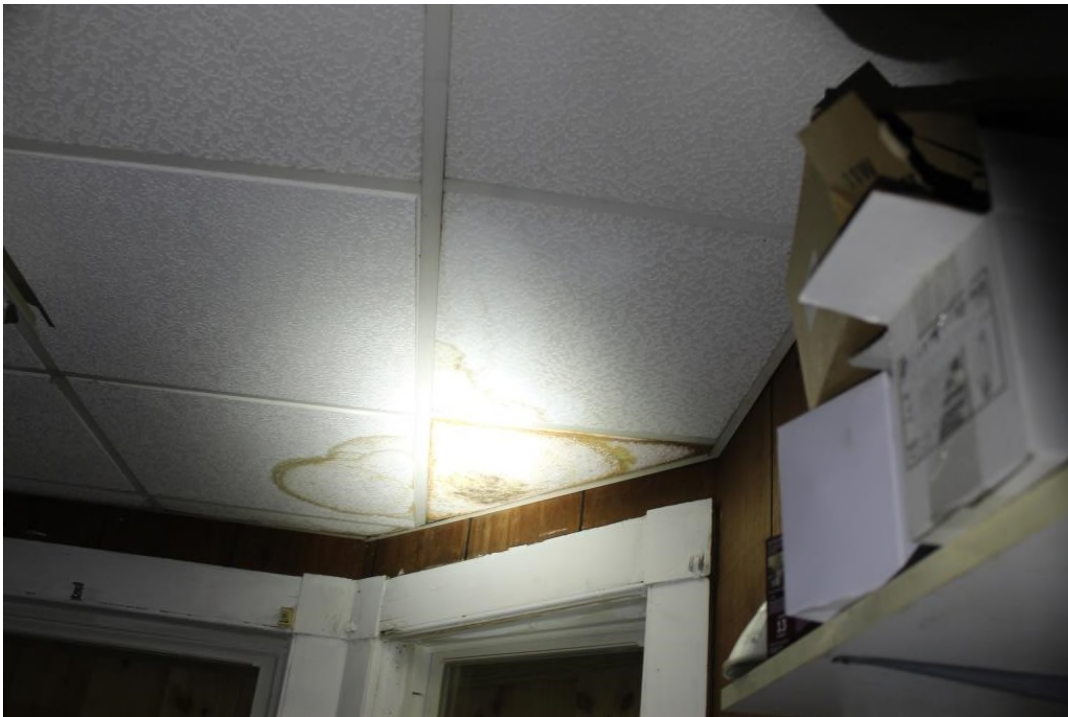
Photo No. 30: Water stains on drop ceiling panel of second floor.

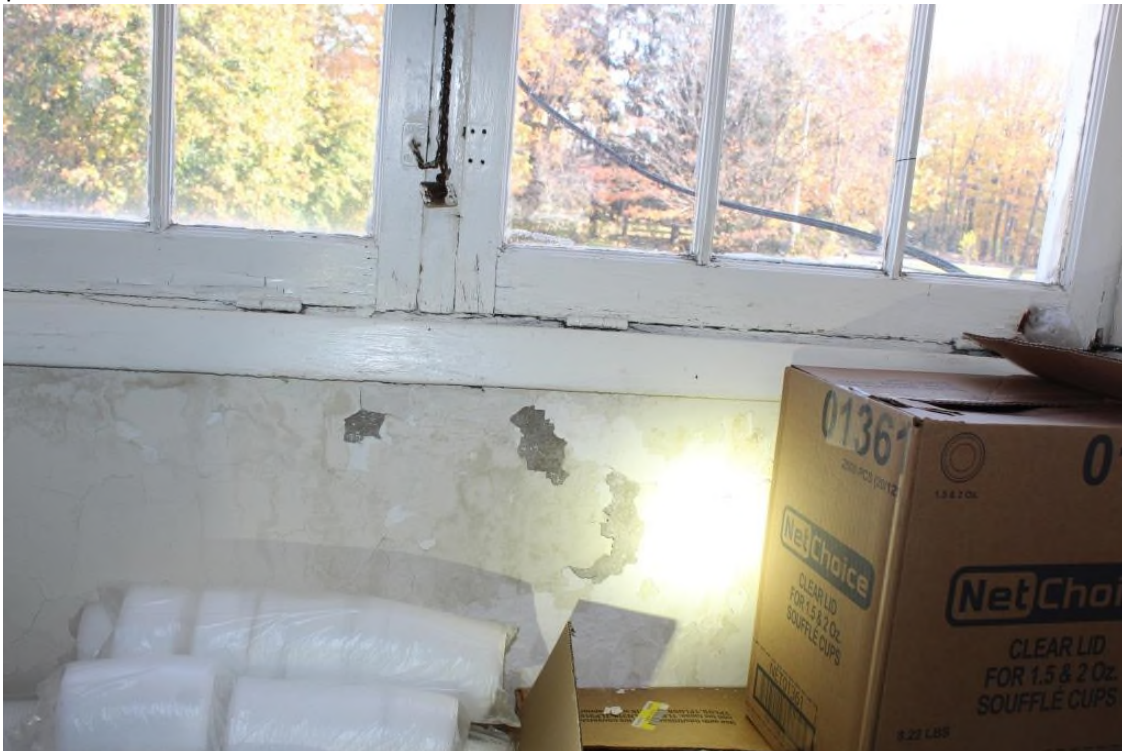
- **Windows:** The first-floor windows appear to be in fair condition. The windows on the second floor and attic have deteriorated and should be replaced. While they can be made weatherproof, they do not meet current energy code requirements.

Photo No. 32: Deteriorated windows on second floor kitchen storage area of infill seen above.

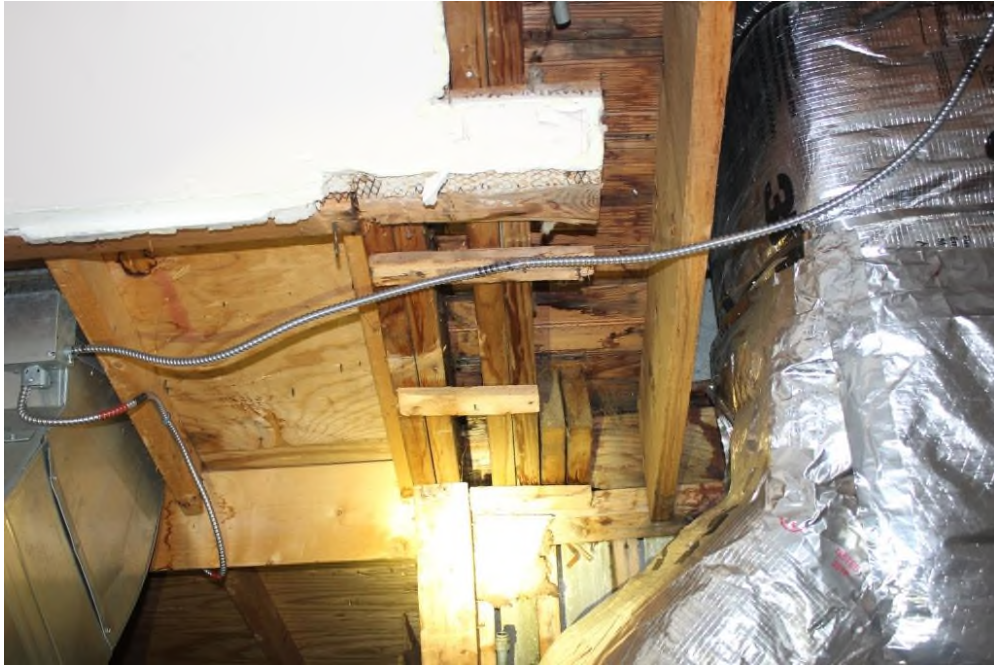
Photo No. 33: Water damage and improper and inadequate roof framing exposed inside second floor mechanical room adjacent to infill addition

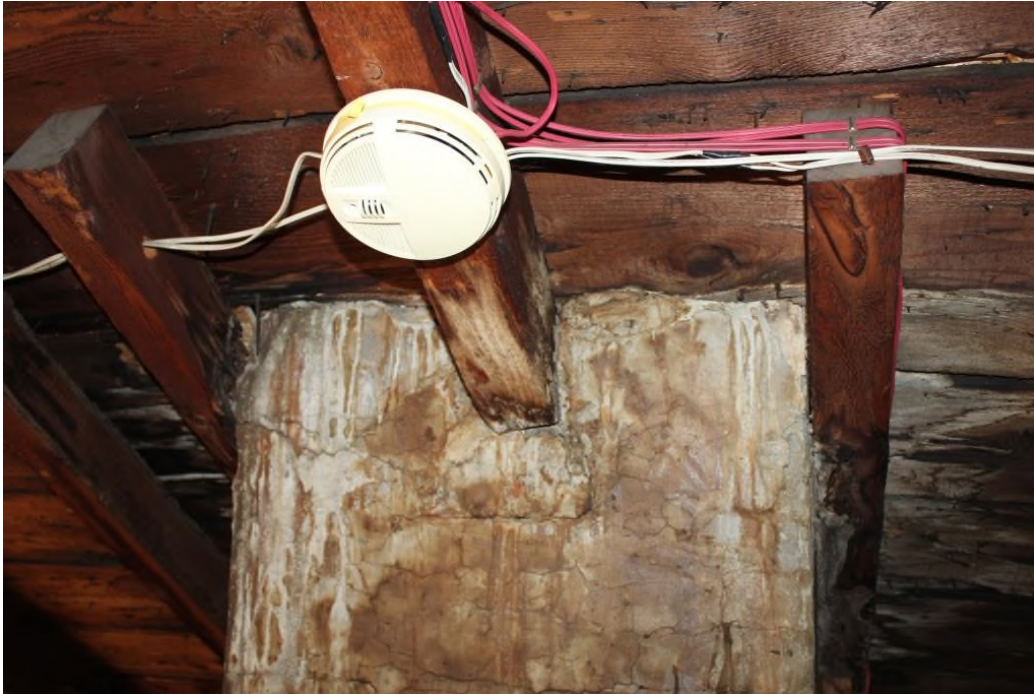
- Water stains were present on the planks and rafters throughout the attic.
- There was severe water staining and rot around chimney, and evidence of prior repairs was noted.

Photo No. 35: Framing condition at chimney. Note water damage.

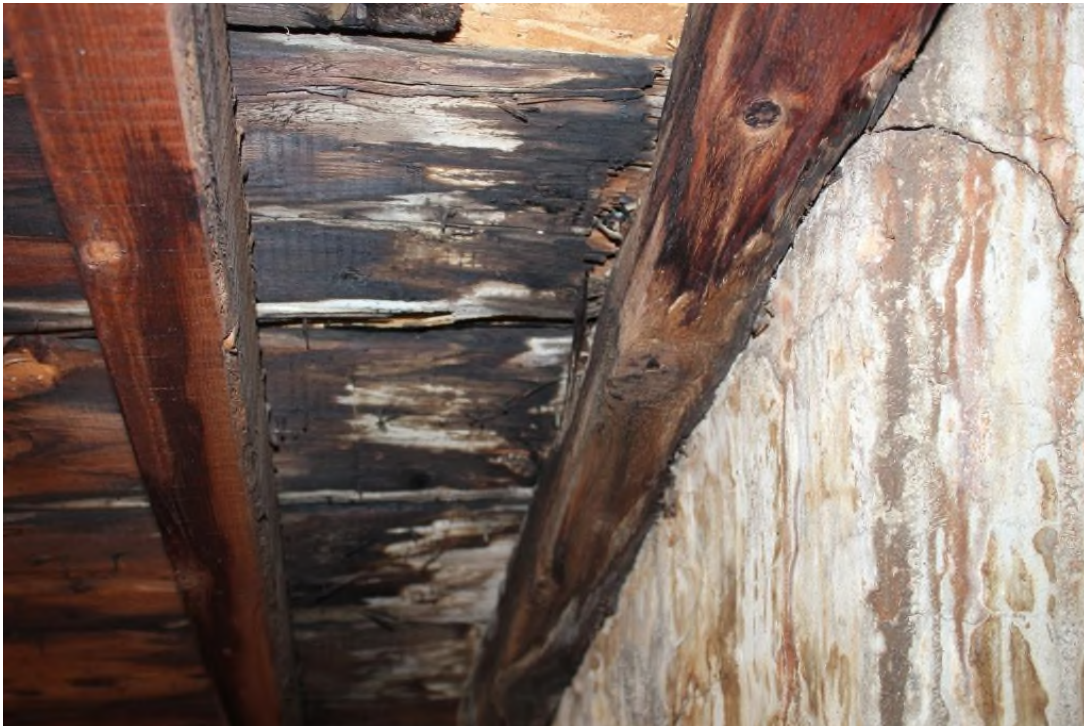
Photo No. 36: Water staining and damage to rafters and plank along the side of the chimney.

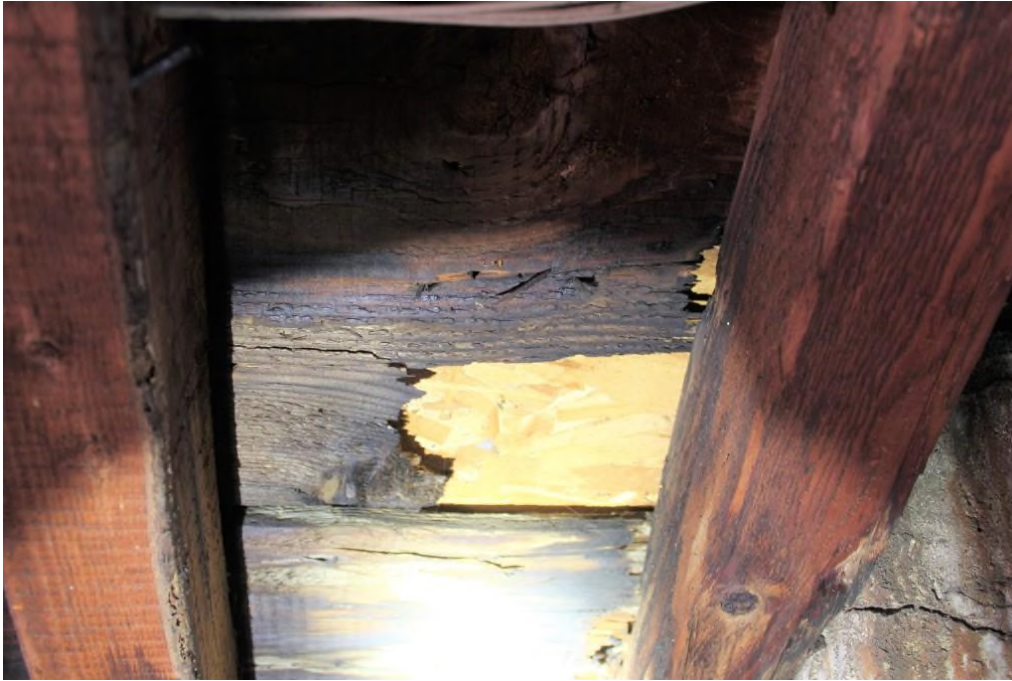
Photo No. 37: Enlarged detail of damage to roof plank covered with OSB.

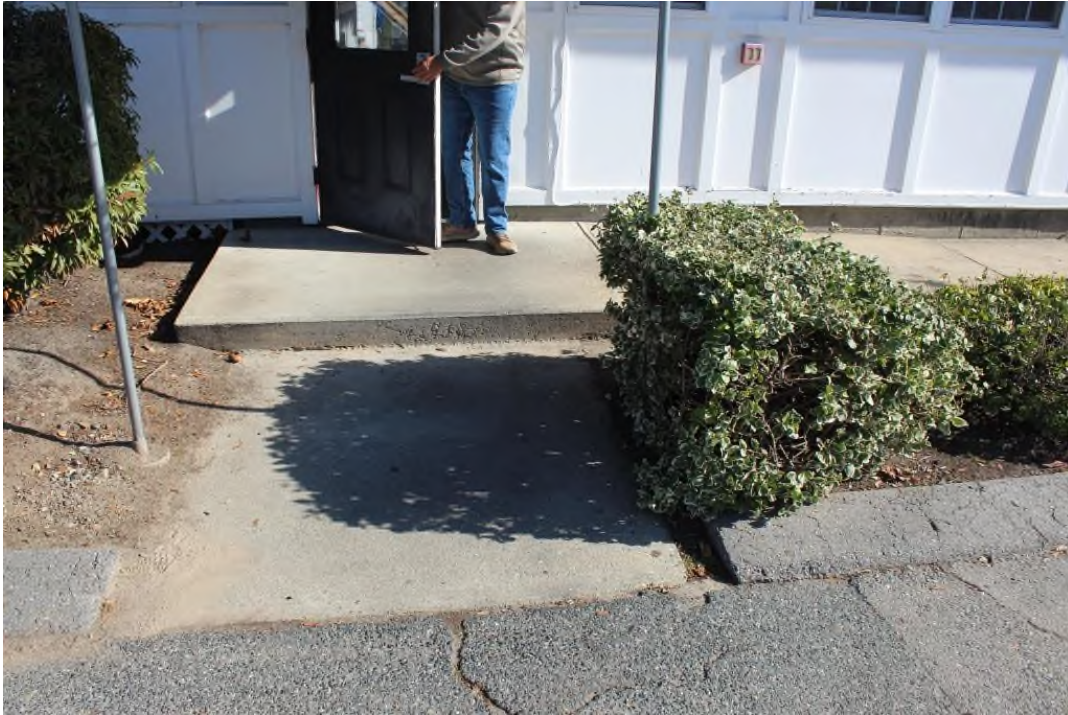
Photo No. 47: Unmarked front step at entrance to restaurant. HC ramp to right.
